Electrical Failure of an Accelerator Pedal Position Sensor Caused by a Tin Whisker and Discussion of Investigative Techniques Used for Whisker Detection

Focus of this Presentation

Failure Analysis of 2003 Camry APP Sensor

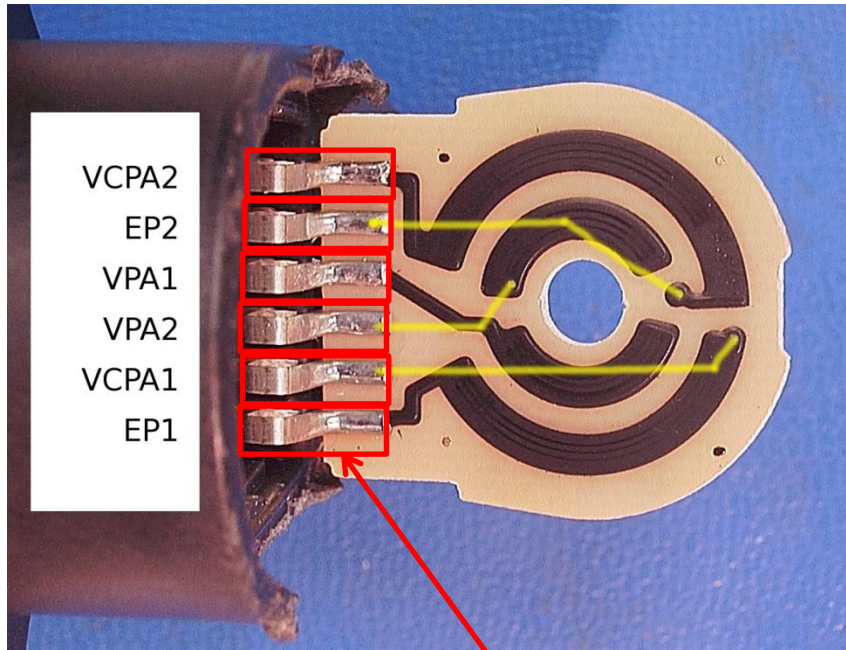
Tin-plated Cu alloy

- Ribbon Leads are a Copper Alloy Coated with 2 μm of Pure Tin
 - Confirmed by XRF & EDS
- No other coatings present on Ribbon Leads (i.e., no conformal coating over them, no intermediate plating layers)
- Separation between adjacent terminals varied from 1000 to 1500 μm
- Dual potentiometers produce independent electrical signals based upon pedal depression angle (VPA1 and VPA2)

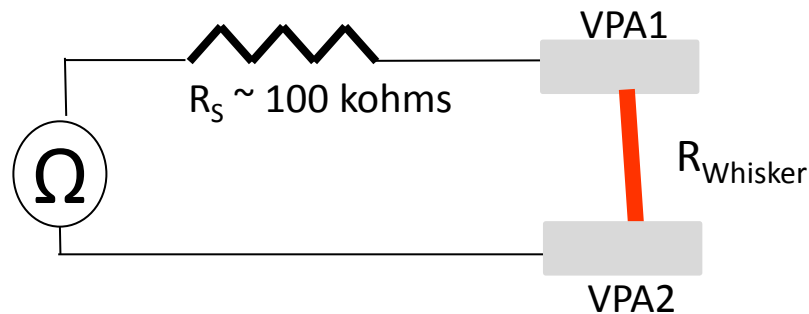
- APP sensor brought into the parts analysis lab at Goddard for further analysis
 - Intermittent resistance behavior confirmed
- Disassembly methods chosen to preserve evidence of conductive debris
 - Plastic housing removed without delivering shocks or introducing debris
 - Shorting resistance was continually monitored using a Fluke 87V multimeter in series with a $100\text{k}\Omega$ protection resistor, and shown to remain at 238Ω throughout disassembly, except for several excursions to “open circuit” ($>50\text{M}\Omega$) followed by return to about 238Ω

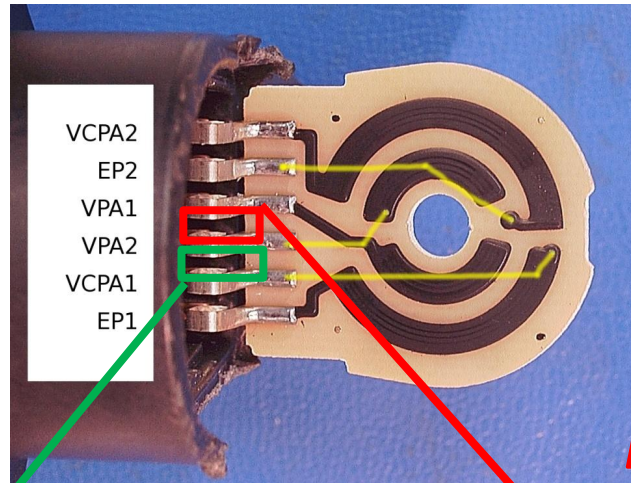
The Two Longest Tin Whiskers Observed in Faulty 2003 Toyota Camry APP Sensor

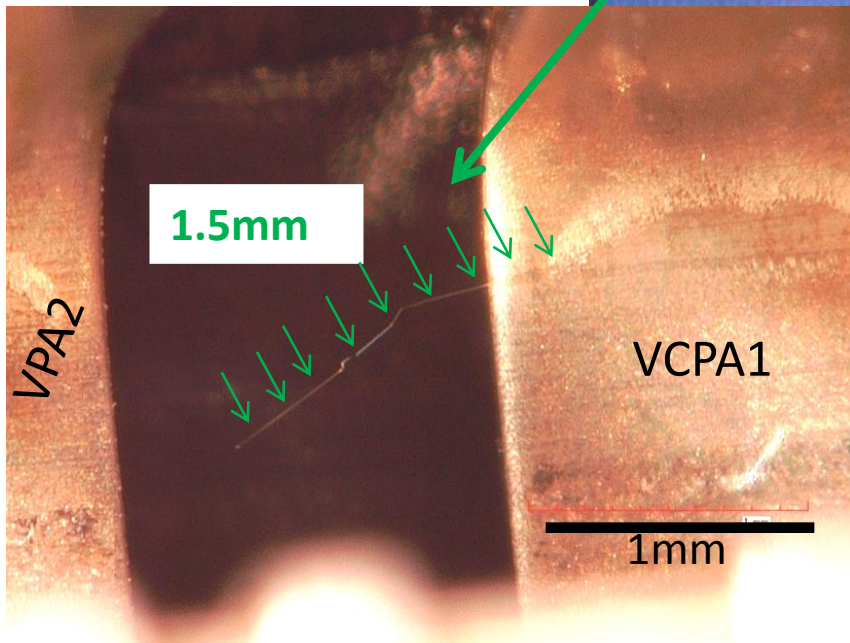
Tin Whisker Almost Bridging Between VPA2 and VCPA1

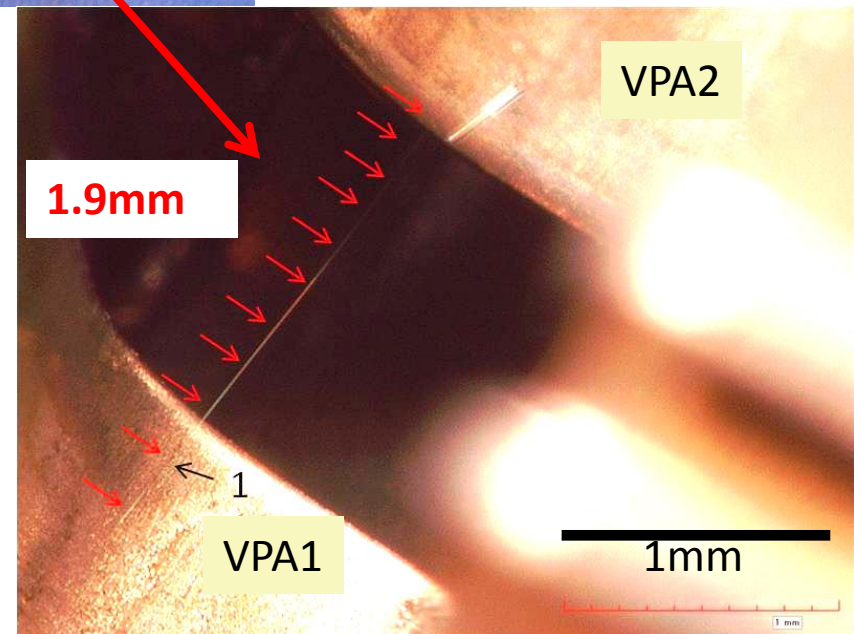
- Resistance measurements between all combinations of external APP sensor connector pins detected an intermittent resistive short between VPA1 and VPA2
 - Measurements made using multiple multimeters
 - Initially, $\sim 3.5\text{M}\Omega$, dropping to $\sim 5\text{k}\Omega$, and then remaining between 238Ω to 250Ω , until the pedal assembly was mechanically shocked
 - Mechanical shock to the pedal assembly returned the resistance to $\sim 3.5\text{M}\Omega$ and further pedal actuations dropped the resistance again to $\sim 5\text{k}\Omega$ and finally to the range between 238Ω to 250Ω
 - This shorting resistance remained unchanged throughout the entire range of travel of the pedal, except when mechanical shocks were delivered

Tin Whisker Shorting Between VPA1 and VPA2

- Where ρ = resistivity of Sn $\sim 11.5\mu\Omega$ cm;
 - L = length of whisker;
 - A = cross sectional area of whisker = $\pi \frac{d^2}{4}$
where d = diameter of whisker (approximating thickness of whisker)
- Therefore, since L= 1900 μm , R = 238 Ω , then
 $d \sim 1.1 \mu\text{m}$
 - This is in line with typical thicknesses of tin whiskers

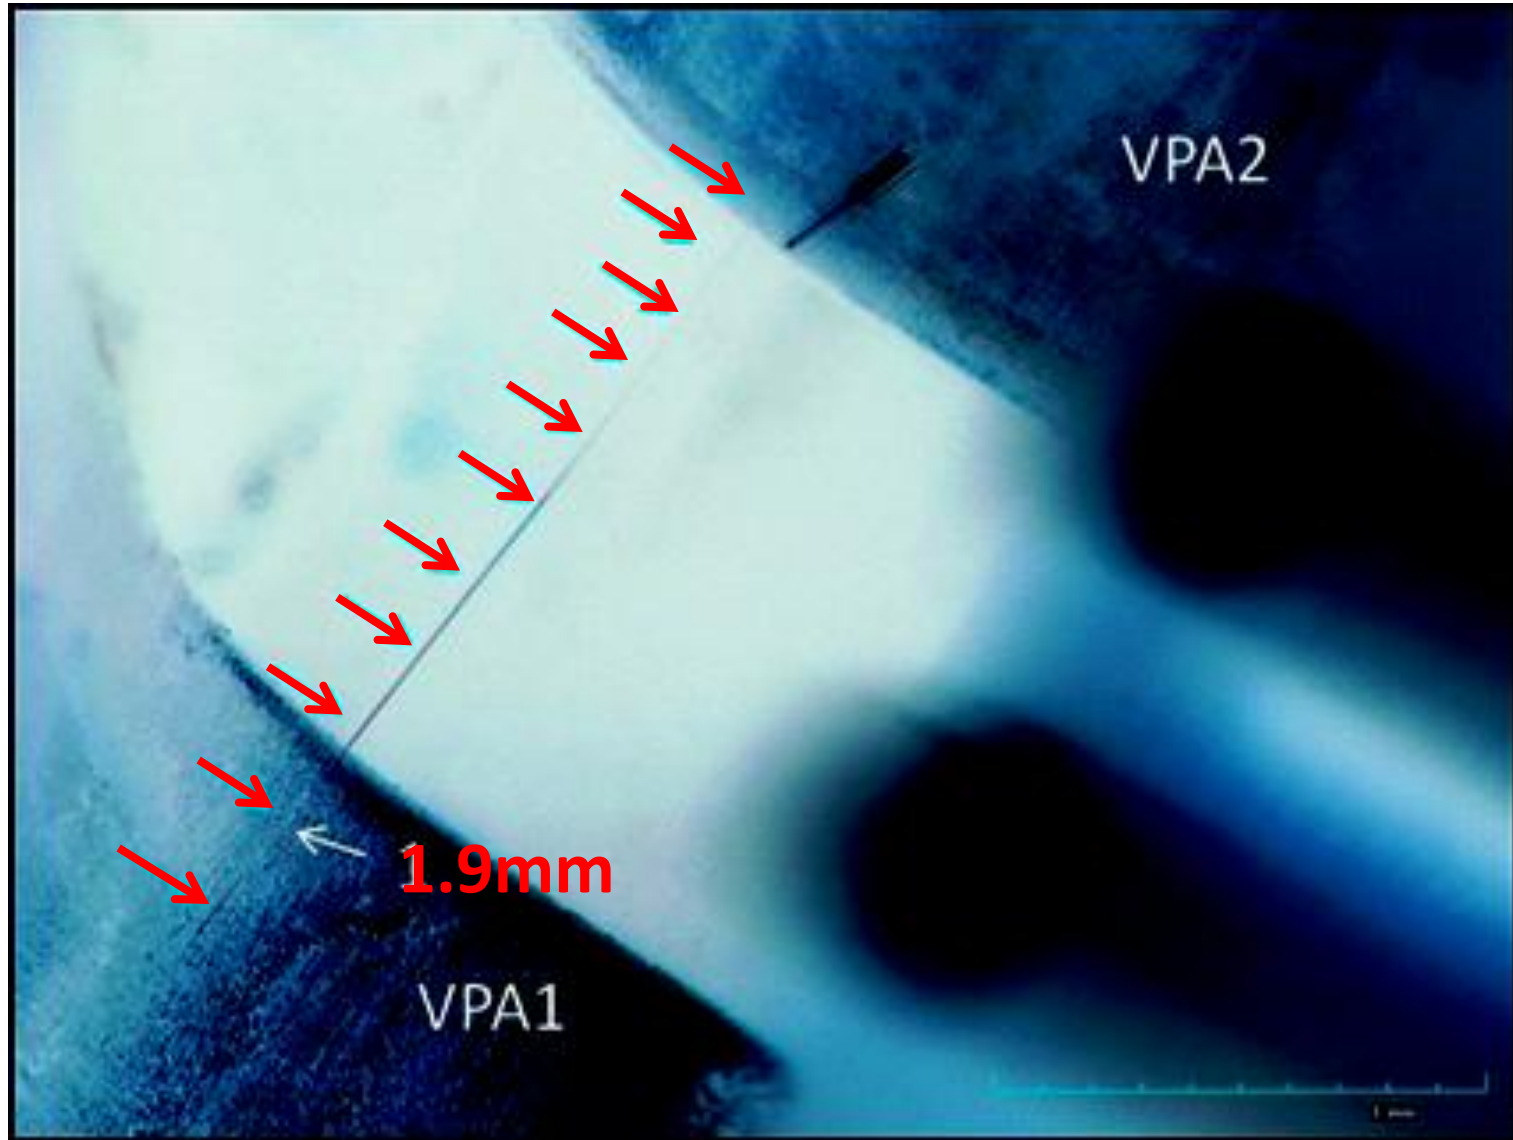
Whiskers in Faulty 2003 Toyota Camry APP Sensor

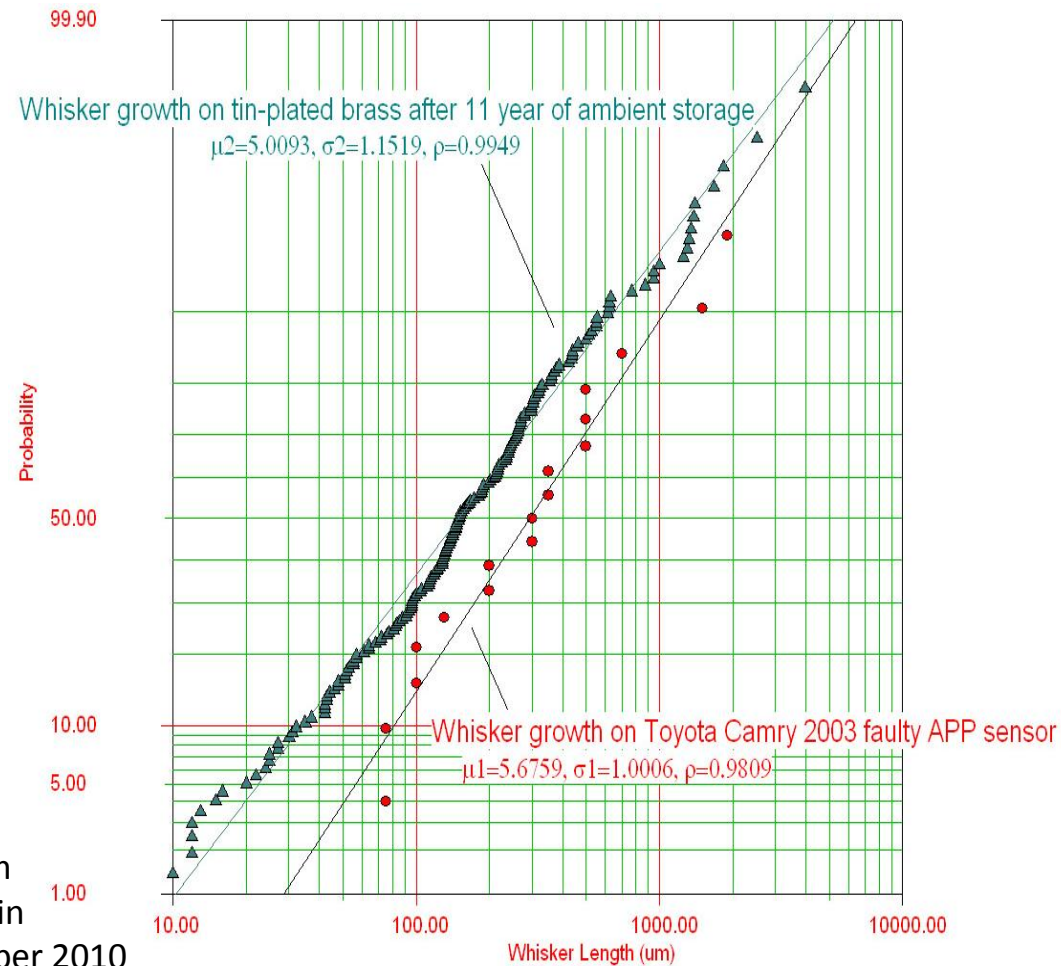
Whiskers $>50\mu\text{m}$ in Length found on the Faulty 2003 Camry APP Sensor

- 17 whiskers with lengths $>50\mu\text{m}$ were observed on the faulty 2003 Camry APP sensor
 - Whisker lengths on APP sensor may actually be longer than shown due to measurement technique
- Whisker growth seen on faulty APP sensor is not ‘out of family’
 - Compare to whisker length data collected for tin-plated brass after 11 years of ambient storage*
