Electrical Failure of an Accelerator Pedal Position Sensor Caused by a Tin Whisker and Discussion of Investigative Techniques Used for Whisker Detection

Focus of this Presentation

Failure Analysis of 2003 Camry APP Sensor

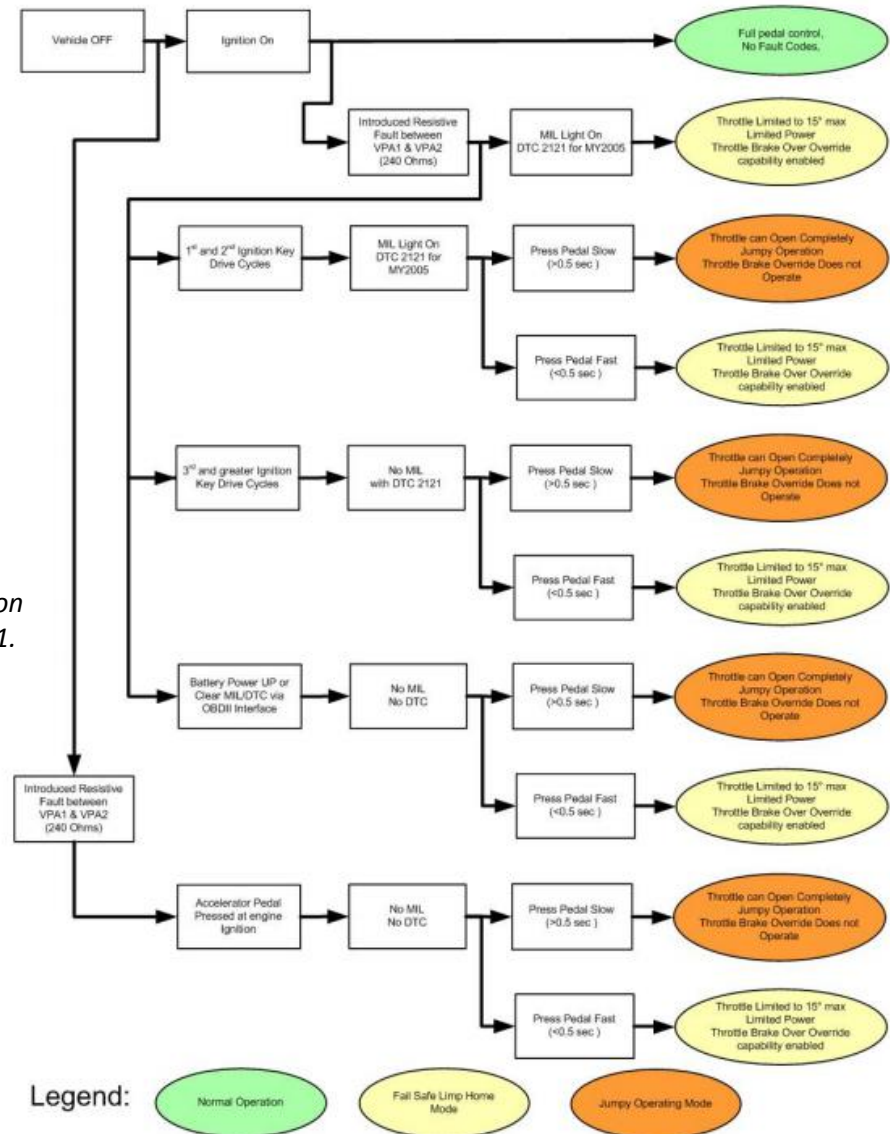
Figure 6.6.2.3-2. Pedal Resistive Fault Event Sequence Diagram

- Destructive physical analysis of a failed pedal assembly from a consumer vehicle with a diagnostic trouble code found a tin whisker had formed a 248 ohm resistive short between VPA1 and VPA2
- A second tin whisker of similar length was growing from a 5 volt source terminal adjacent to a pedal signal output terminal, but had not made contact with any other terminals. Inspection of “non-failed” potentiometer pedals revealed tin whiskers present in similar locations as the failed pedal

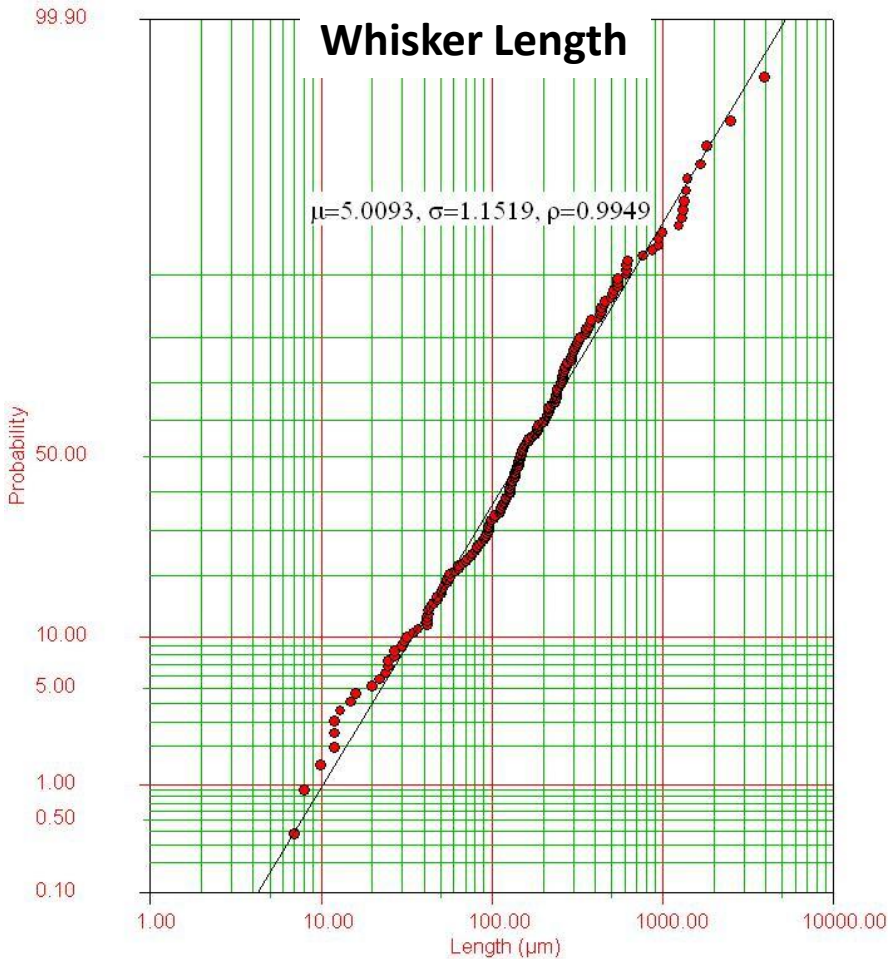
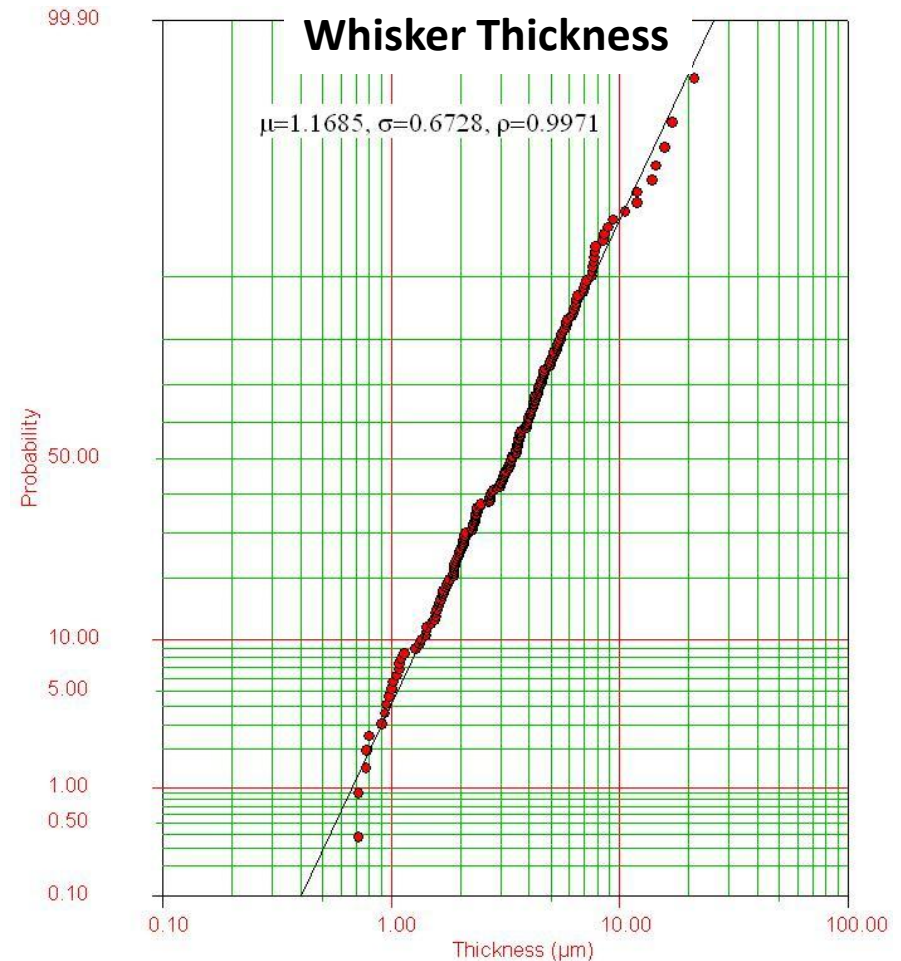
Example of Tin Whisker Length and Thickness Distributions

Collected for 187 whiskers on tin-plated brass that grew over 11 years of ambient storage

- 17 whiskers with lengths $>50\mu\text{m}$ were observed on the faulty 2003 Camry APP sensor
 - Whisker lengths on APP sensor may actually be longer than shown due to measurement technique
- Whisker growth seen on faulty APP sensor is not ‘out of family’
 - Compare to whisker length data collected for tin-plated brass after 11 years of ambient storage*

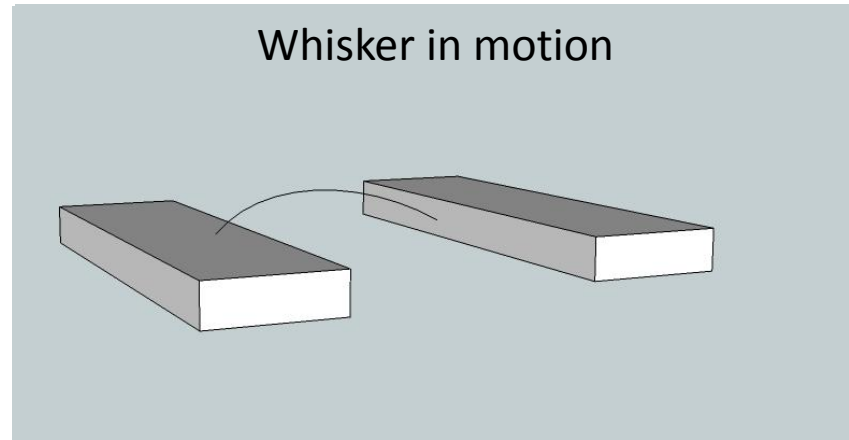
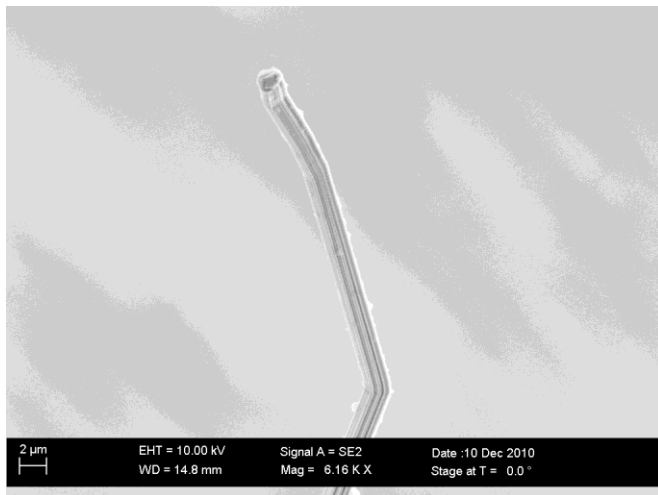
Illustration of How a Whisker may Snag

- Long, thin whiskers are ductile. Without breaking they can bend, flex through very large angles under the influence of air, vibration, shock, electrostatic forces
- After significant movement, whisker tip may be caught by the irregular surface of the tin plating on an adjacent conductor
 - Mechanical shock or air movement may dislodge the whisker tip
- **Insulating films may prevent immediate electrical continuity**
 - See next slide for more detail

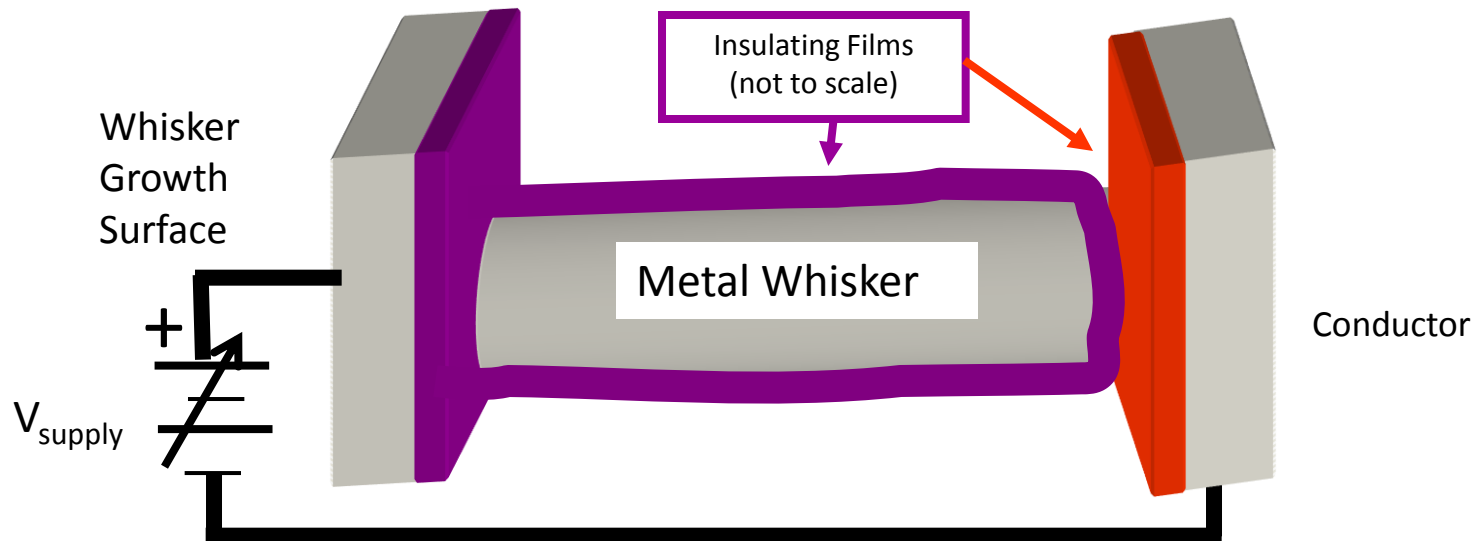
Metal Whiskers and Adjacent Conductors Grow Insulating Films

- Electrically insulating films form within hours on metal whiskers and adjacent conductors
 - Oxides, sulphides, sulphates, chlorides, hydrides, etc.
- These films act as barriers to electrical current flow UNLESS applied voltage exceeds “dielectric breakdown” strength of the combined films
 - Direct **MECHANICAL** contact does NOT guarantee **ELECTRICAL** contact
 - Courey (NASA), among others, have measured the breakdown voltage of films on tin whiskers
 - V_{BD} fit a probability distribution with a wide range (~60mV to >45Volts)
 - Insulating effects of these films are important to recognize
 - Has fooled failure analysts when bench testing (e.g., Ohm-meter) to detect shorts
 - Can explain survival of some electronics in the field despite whisker infestation

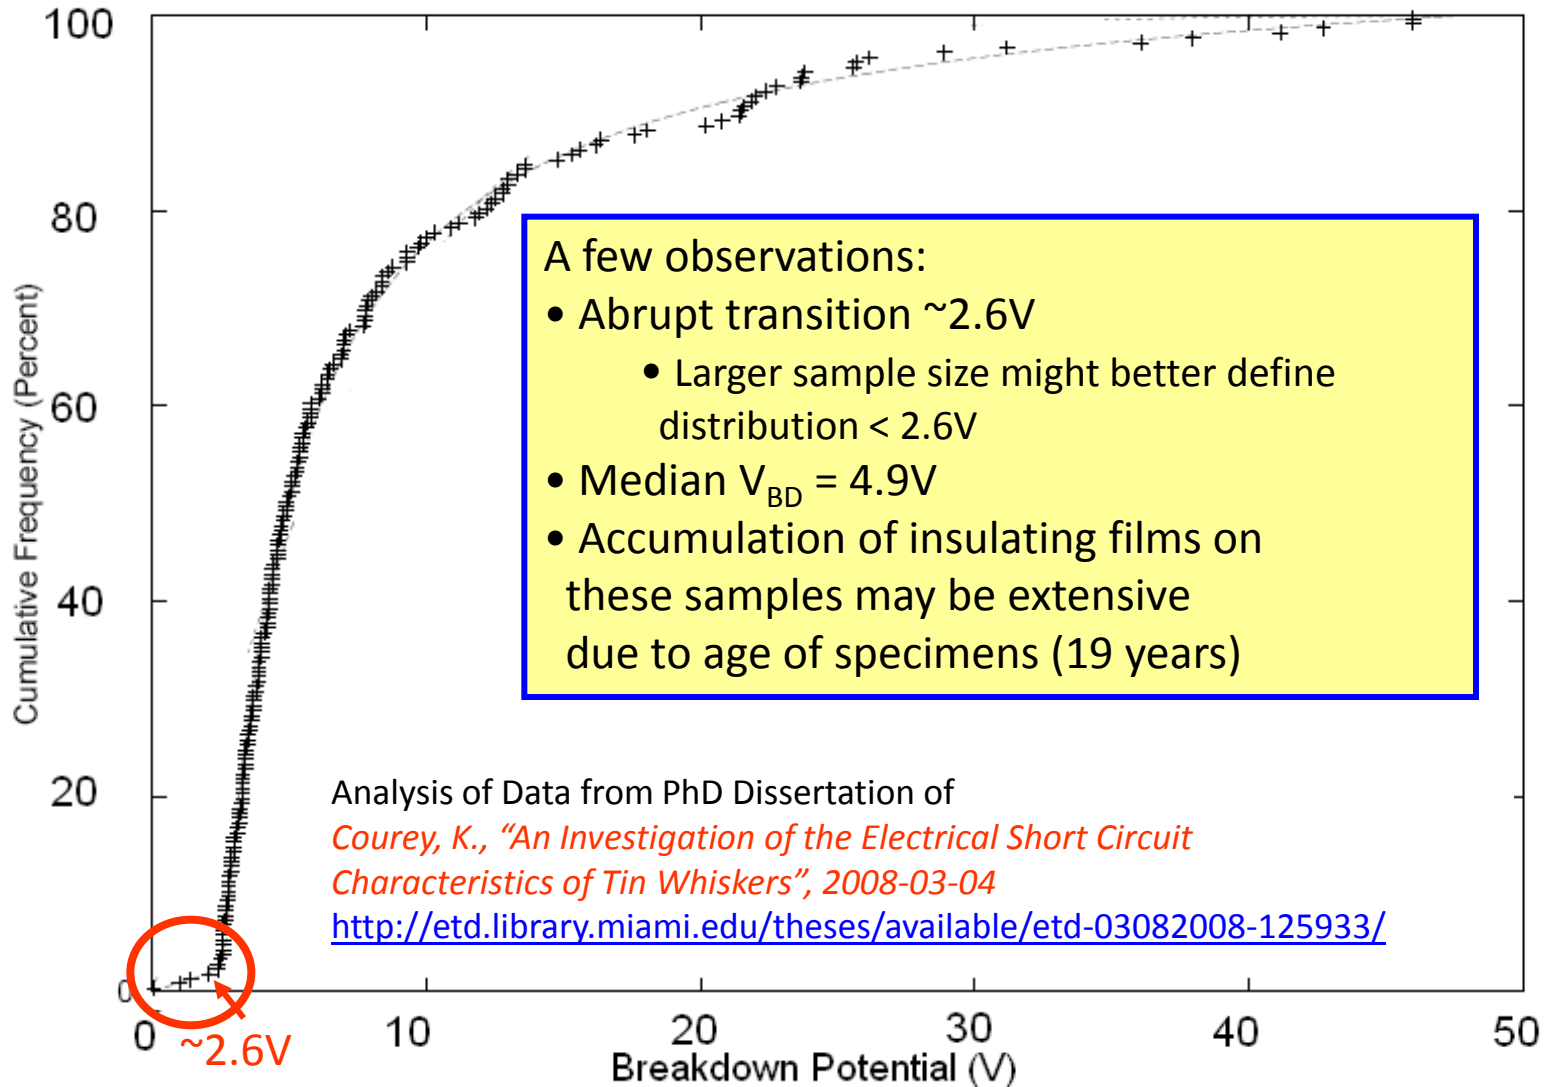
Breakdown Potential of Insulating Films on 200 Tin Whiskers from ~19 Year Old Space Shuttle Hardware when probed using gold-plated probe

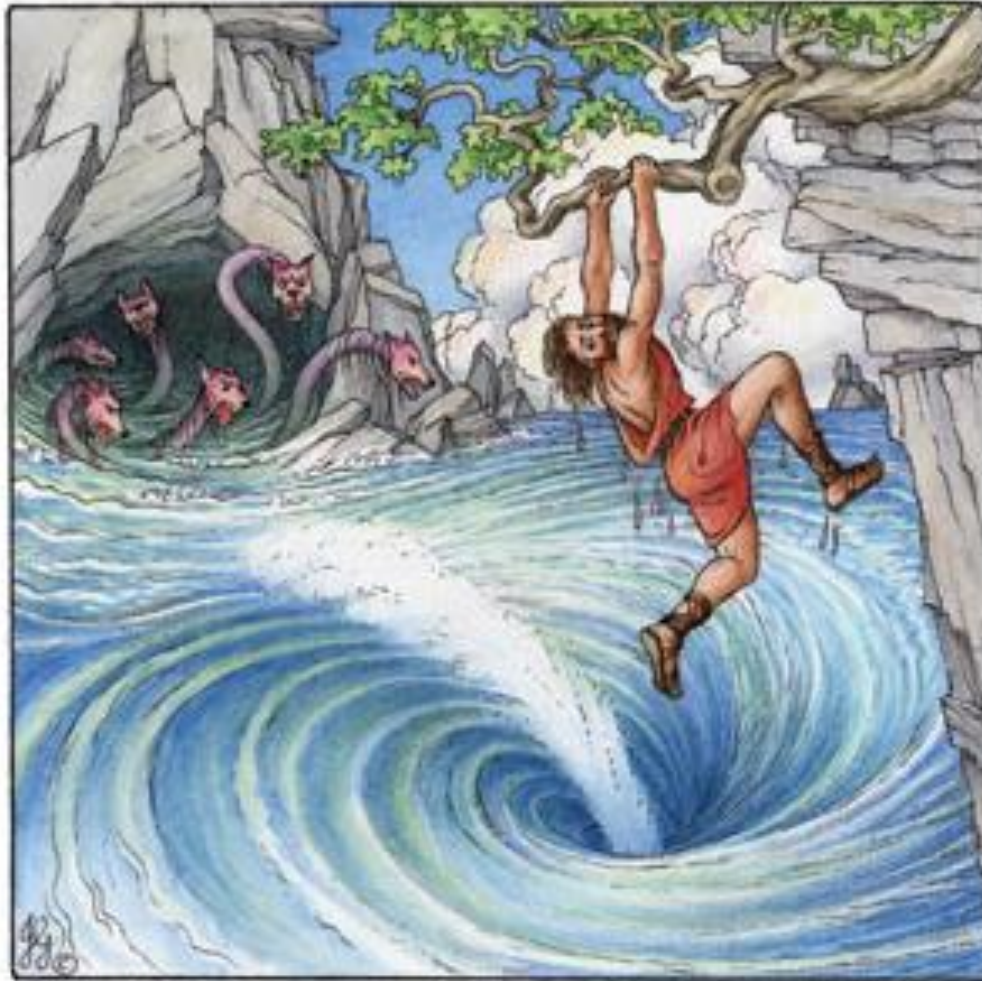
Beware of Ohm-Meter Limitations

- Published research shows that ohm-meters detect less than 10% of the bridging whiskers, and sometimes less than 1%
- The investigator may conclude **“No Fault Found”**
 - Ohm-meter may supply $V_{out} < V_{breakdown}$ for the insulating films (oxides, moisture) that form on a metal whisker. No Current will flow – the whisker remains undetected during the few seconds of examination.
“No Fault Found”
 - Ohm-meter may supply $V_{out} > V_{melt}$. Current Will Flow, the whisker melts in less than 1 ms -- no detection happens. There is no longer a bridging whisker to detect.
“No Fault Found”
- Range switching can have the ability to deliver whisker-killing impulses

Electrical Detection of Whisker Short Melting Whisker vs. Insulating Film Interference
