787 Lithium-ion Battery Events

A Guide for Fire Fighters

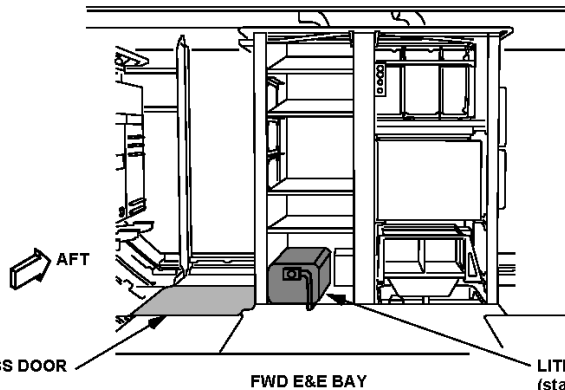
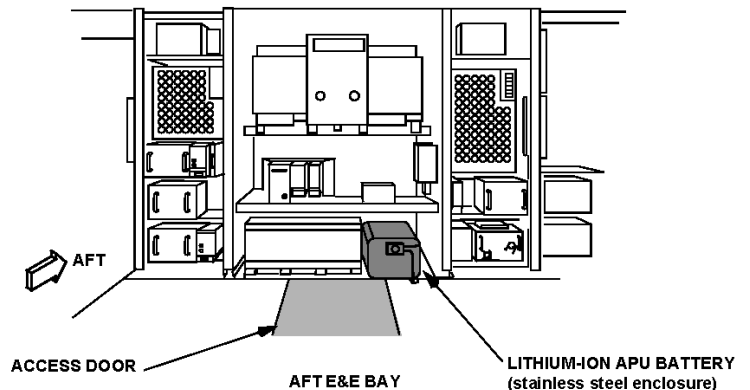
787 Battery Locations

- The 787 is equipped with two primary lithium-ion batteries, which are contained in a stainless steel enclosure with a vent tube leading overboard.
- Each lithium-ion cell contains flammable electrolyte. If the cell has a short circuit or is exposed to high temperatures, it can swell and the electrolyte may vaporize creating internal pressure which then may vent overboard.
- The Boeing Aircraft Rescue and Fire Fighting Information document has been updated to clarify 787 battery information.
- Boeing has developed recommended fire fighting procedures to follow if a lithium-ion battery event occurs.

Lithium-ion Batteries

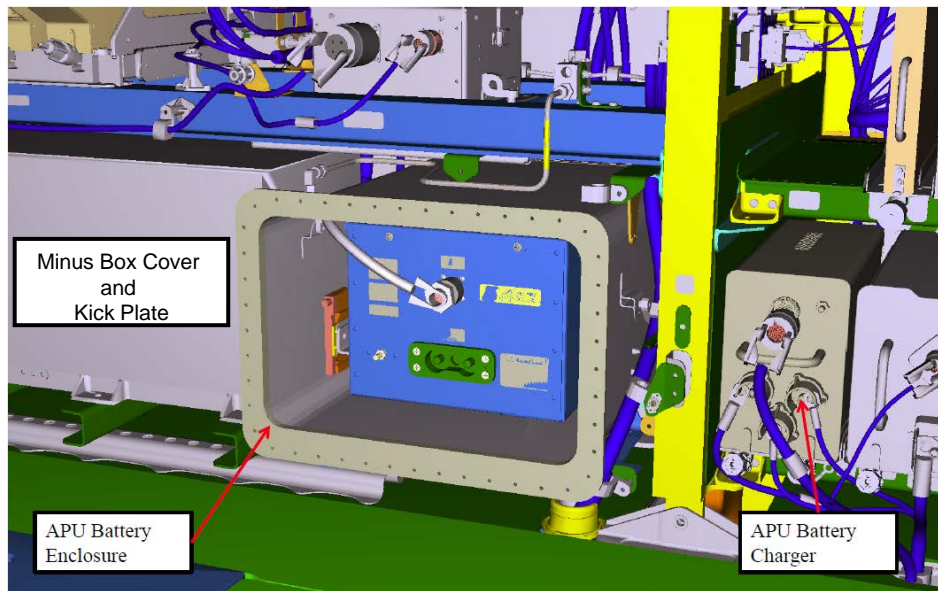
View Looking Aft

The box containing the lithium-ion battery cells is secured inside a reinforced stainless steel enclosure capable of containing a lithium-ion battery event. Venting of vapor during a battery failure event may be visible from an exterior vent on the bottom of the airplane under the forward or aft Electrical and Electronic (E&E) bay.
